MRBC Voluntary Floodproofing Cost-Share Assistance Program

PROJECT: Single story, “L”-shaped, slab-on-grade Ranch Home located in the Floodway-Fringe of Little Cedar Creek in southeastern Noble County suffered Flood Damages three (3) times from 1989—1996. This Repetitive Loss structure was constructed before the Special Flood Hazard Area had been identified. Prior to 1989, this property had never flooded.

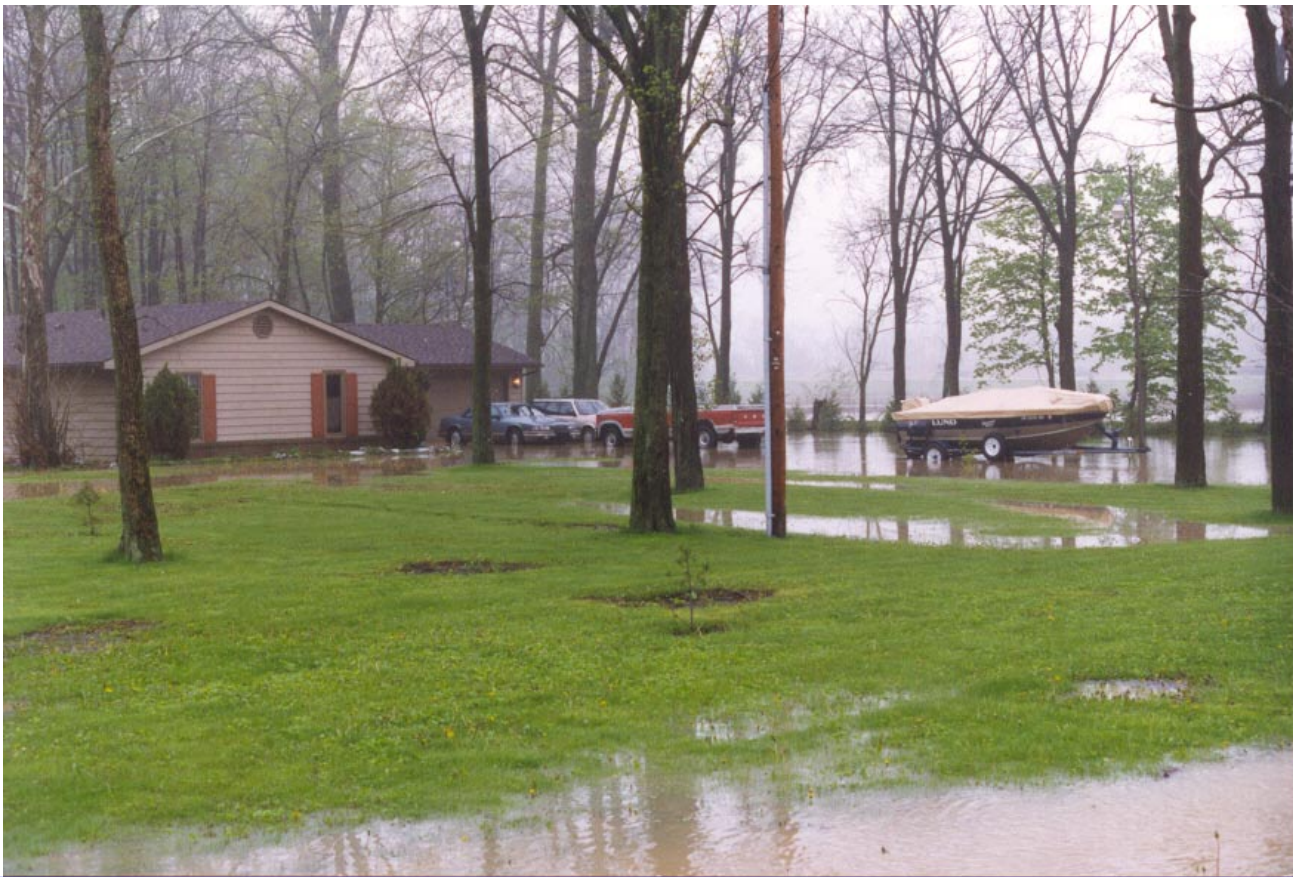
Repetitive Loss Structure with sandbags still visible. Three (3) NFIP claims filed in a ten year period. Average annual flood damages: +/- \$20,000.00.

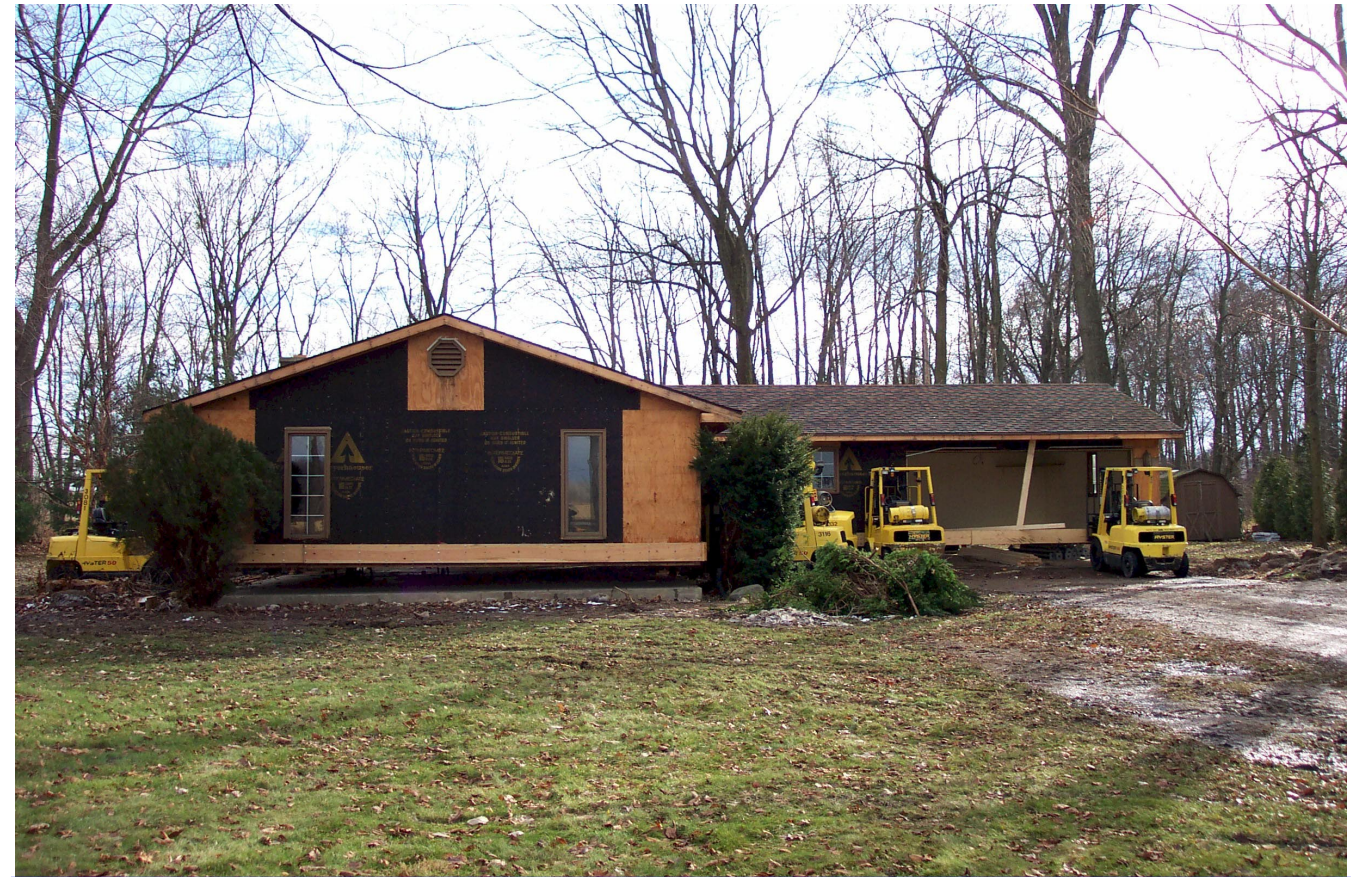
Preparing for “Lift-Off”. A total of ten (10) hydraulic forklifts were used to lift this “slab on grade” structure. Structure’s “L-shaped” configuration contributed to the difficulty in this elevation project.

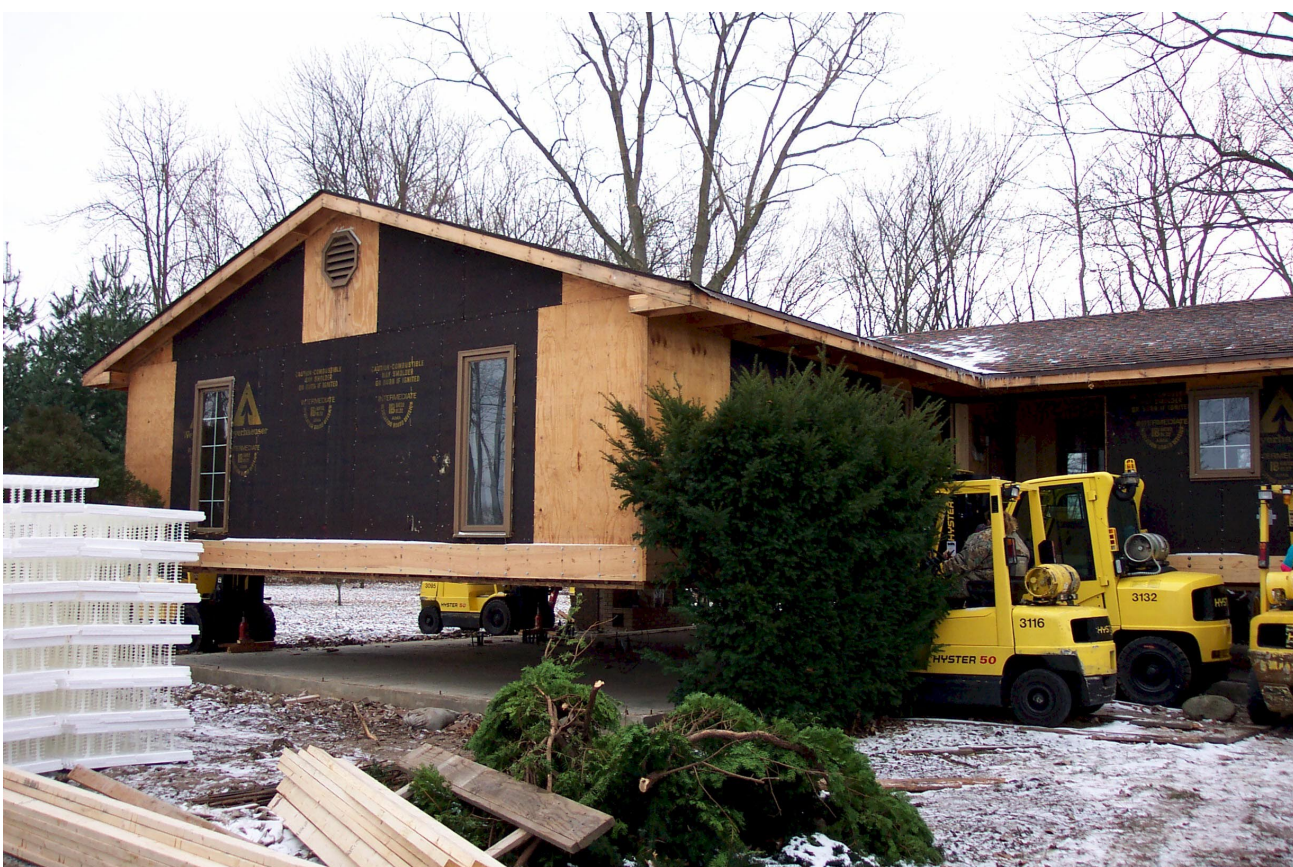
Following examples from the Baton Rouge, Louisiana area, the homeowners chose to lift the structure a total of eight feet (8’). Flood Protection requirements called for elevating the structure +/- five feet (5’). **Note:** The enclosed area below the structure **SHALL NOT** be converted to living space per Federal Regulations. Homeowner’s were required to sign a “Deed Restriction”.

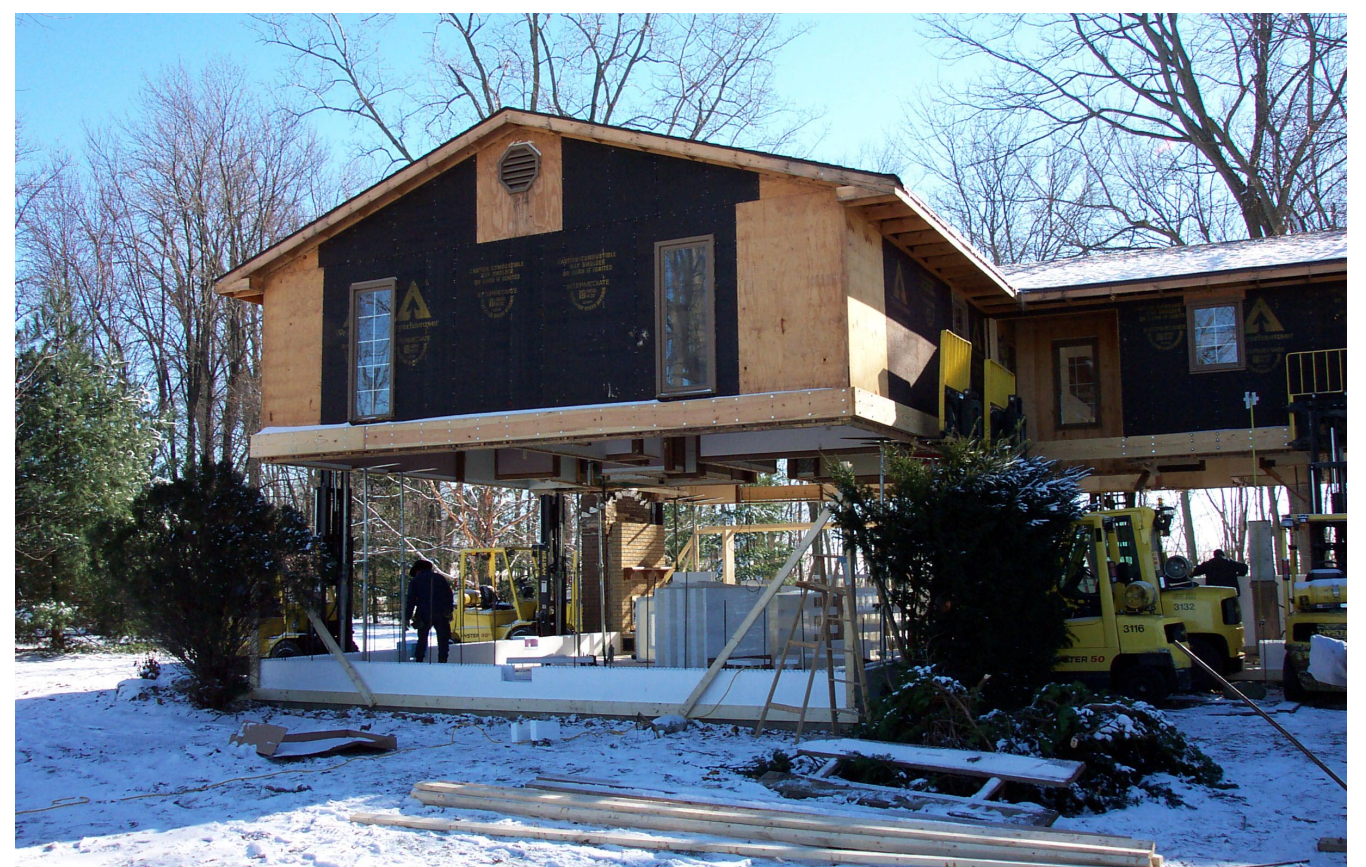
Flood Vents were place within one foot (1’) of the ground. A total of ten (10) Flood Vents were installed to meet FEMA requirements. SMART VENT flood vents were used in this project as they have been approved by FEMA for placement in the walls of enclosed areas. MRBC reserves the right to perform an annual inspection of this home to ensure that vent openings are free of obstruction.

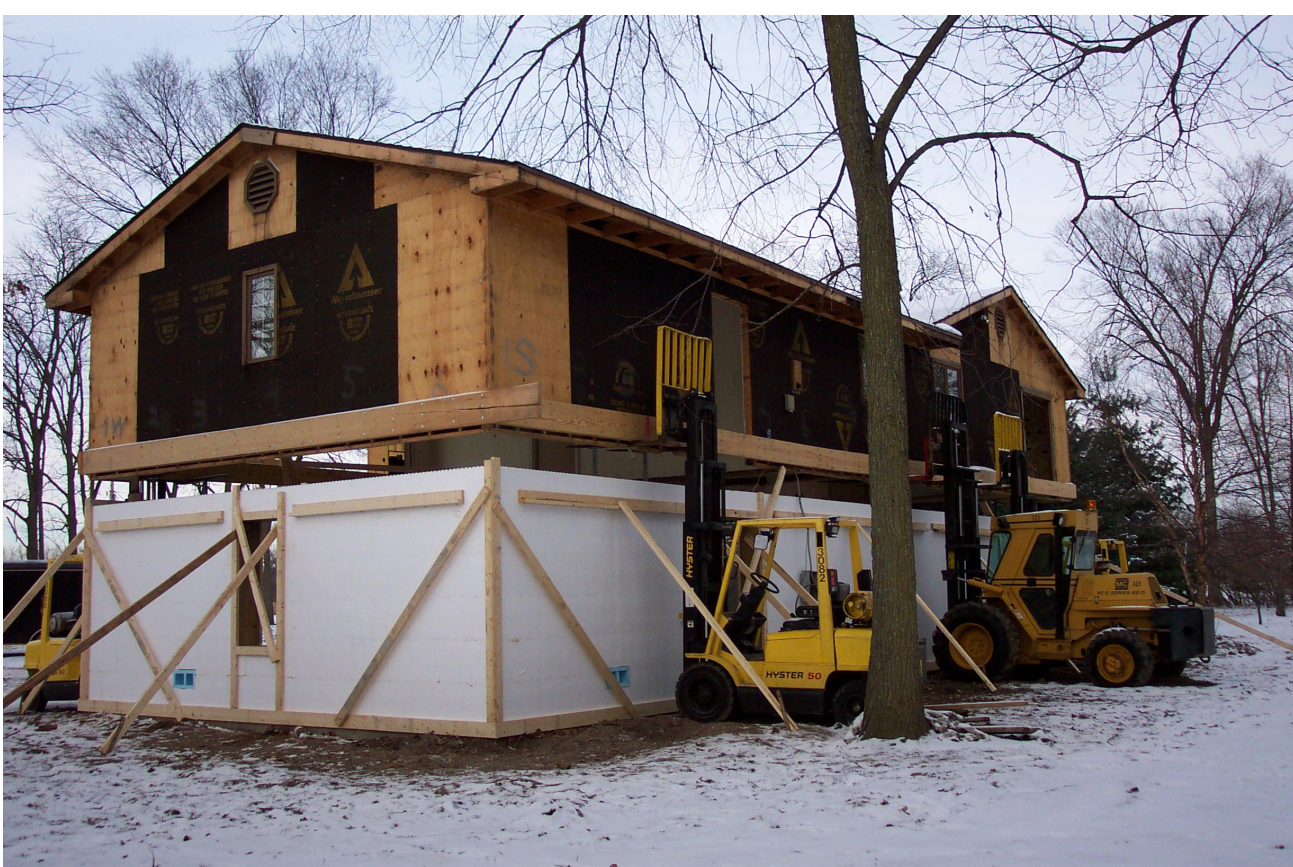
Supporting foundation was constructed using “Insta-form” foundation system blocks. The Styro-foam blocks inter-lock with each other with structural webbing to add strength. Concrete is poured in the forms. Walls have a very high “R” value. **Note:** “Blue Rectangles” are block-outs for FEMA approved Flood Vents to allow floodwater to flow through the structure.
